Maryland Historical Trust
State Historic Sites Inventory Form

Survey No. B-4394

historic 310 W. Saratoga (front) Dept. of General Services
311 W. Mulberry (rear) Saratoga State Center Garage
and/or common

street & number 310 W. Saratoga Street (front) not for publication
311 W. Mulberry Street (rear)
city, town Baltimore vicinity of congressional district Seventh
state Maryland county Baltimore

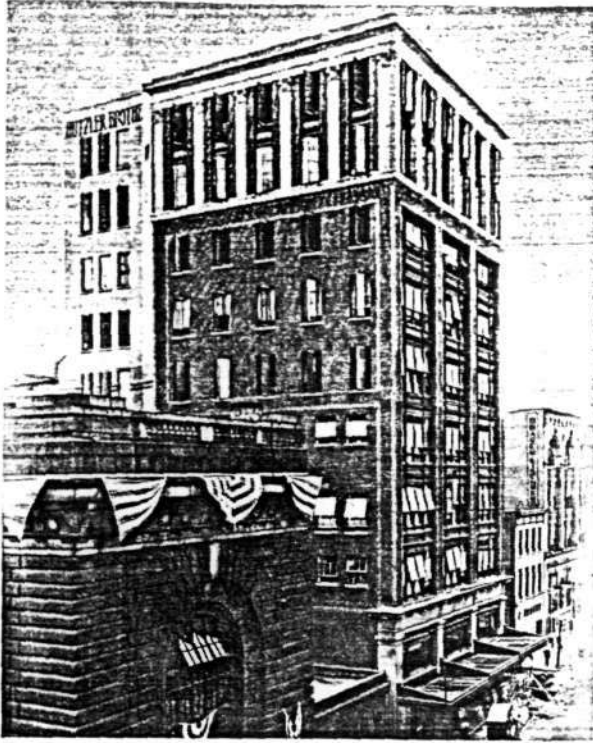
Saratoga Street Building in 1924 after it had been raised from five to ten stories, providing space for sales departments, workrooms and offices.

In 1916, in spite of the uncertainty created by the war then raging in Europe, a handsome five-story building was erected on the south side of Saratoga Street. Simultaneously the properties at 228-232 North Howard Street were remodeled and unified with the rear buildings. The next major expansion came in 1924 (see illustrations above). In 1928 Hutzler's took over 226 North Howard Street as the North Building Annex, and the following year erected the Service Building on the north side of Saratoga Street with a tunnel from the Main Store. The addition of this space made possible the opening of Hutzler's Downstairs, "A Thrift Store with Hutzler Standards."

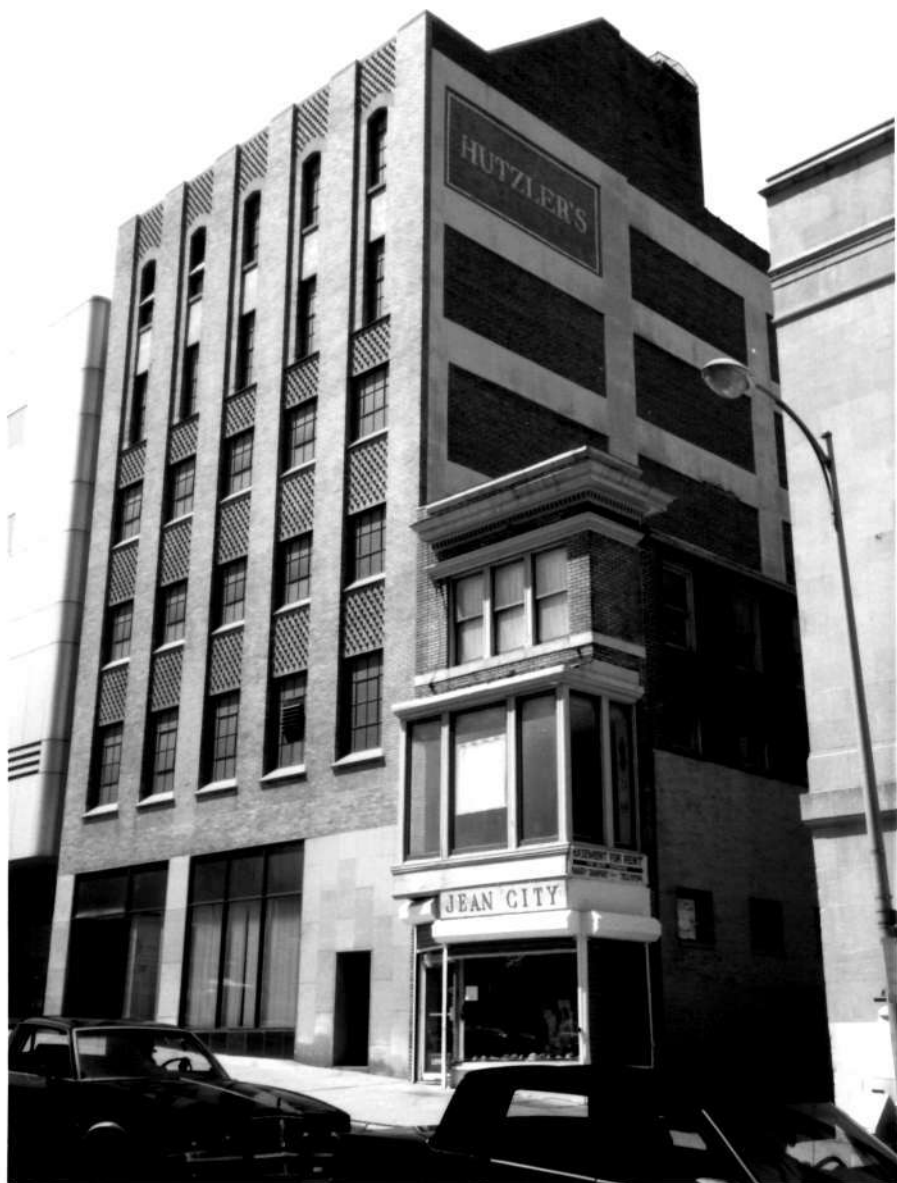
1/7

SE elevation, Saratoga facade

The Saratoga Street facade is designed to hide the fact that the building is a parking garage. The structure appears to be an office building. There is no car entry on this facade, but only on the Mulberry Street facade. Polished granite veneers the wall around the openings. Brown metal panels cover the tops of the openings, and black marble facing covers the foundation wall. The first bay contains a recessed entrance with a glass door and floor-to-ceiling windows along the east wall. The second bay has three large plate glass windows looking into an office. The third bay has a slightly recessed metal door is set into a wall entirely faced with polished granite. The recessed entry, polished granite revetments, and the plate glass windows are post WWII alterations.

The upper stories are unaltered. Six yellow brick piers run the full height of the building and divide it into five bays. The yellow brick forms spandrels between the windows. The spandrels above the second, third, and fourth stories are laid in a toothed, three-dimensional pattern of angled header bricks projecting from a field of stretcher bricks.

The second-story windows are 16-light industrial windows. The third- and fourth-story windows are 12-light industrial windows. The sills on the second, third, fourth and fifth stories are made of angled, bracketed stone.

The windows in the fifth and sixth story bays are treated slightly differently. Within the bays created by the brick piers is a two-story pointed, Saracenic arch composed of brick pilasters and stone voussoirs. Within the narrow openings in the arch narrow industrial windows; those of the fifth story are 4/4 and those of the sixth are eight lights with an angled top.

The wall above the sixth story is flanked by the brick piers and has a continuous band of the toothed brick that is found on the spandrels. The cornice is a simple stone coping.

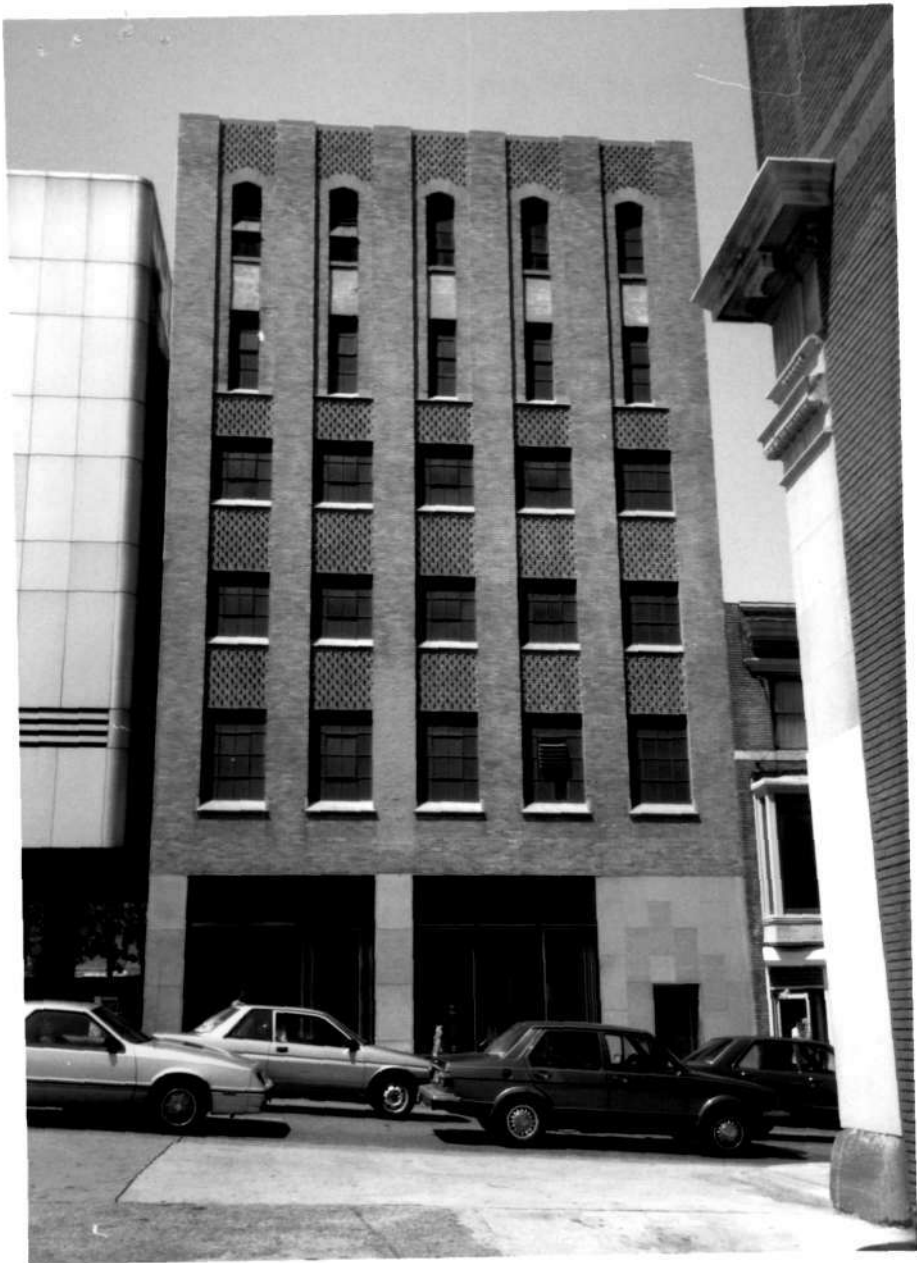
2/7

Facade, south elevation

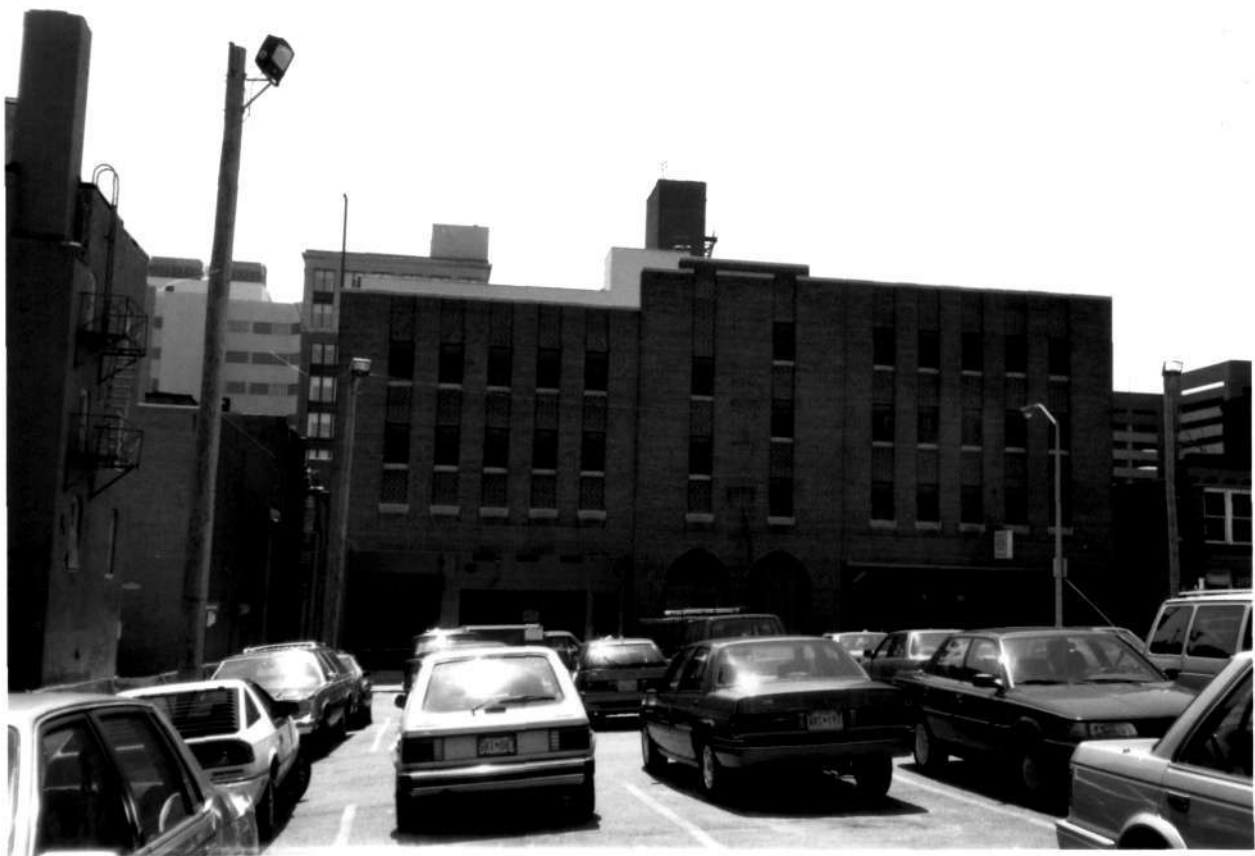
3/7

Facade (near), north elevation

The Mulberry Street facade expresses the garage function only on the first story, which is recessed and contains ramps and loading docks. The facade is laid in dark red brick and the Saratoga Street design of piers and toothed brick spandrels is

repeated on this facade. The building is divided into three large sections with a projecting central portico, a three-story section to the east and a four-story section to the west.

The two-bay central portico rises four stories. It has two large Saracenic arches piercing the wall at ground level. The first story is recessed behind these arches. Office doors are located on the back wall. This section is actually the stair hall and elevator bank for the garage. The rise of the circulation core is expressed on the fenestration of the upper stories, the windows on each story are stepped-up from each other. The first bay has a window in the second and third stories, and the second bay has a window in the second, third and fourth stories. The stepped-up positioning of the two bays means that the first bay window is on line with the spandrel of the second bay. The 6-light industrial windows create vertical stacks that are linked by the toothed brick, header pattern found on the Saratoga Street facade.

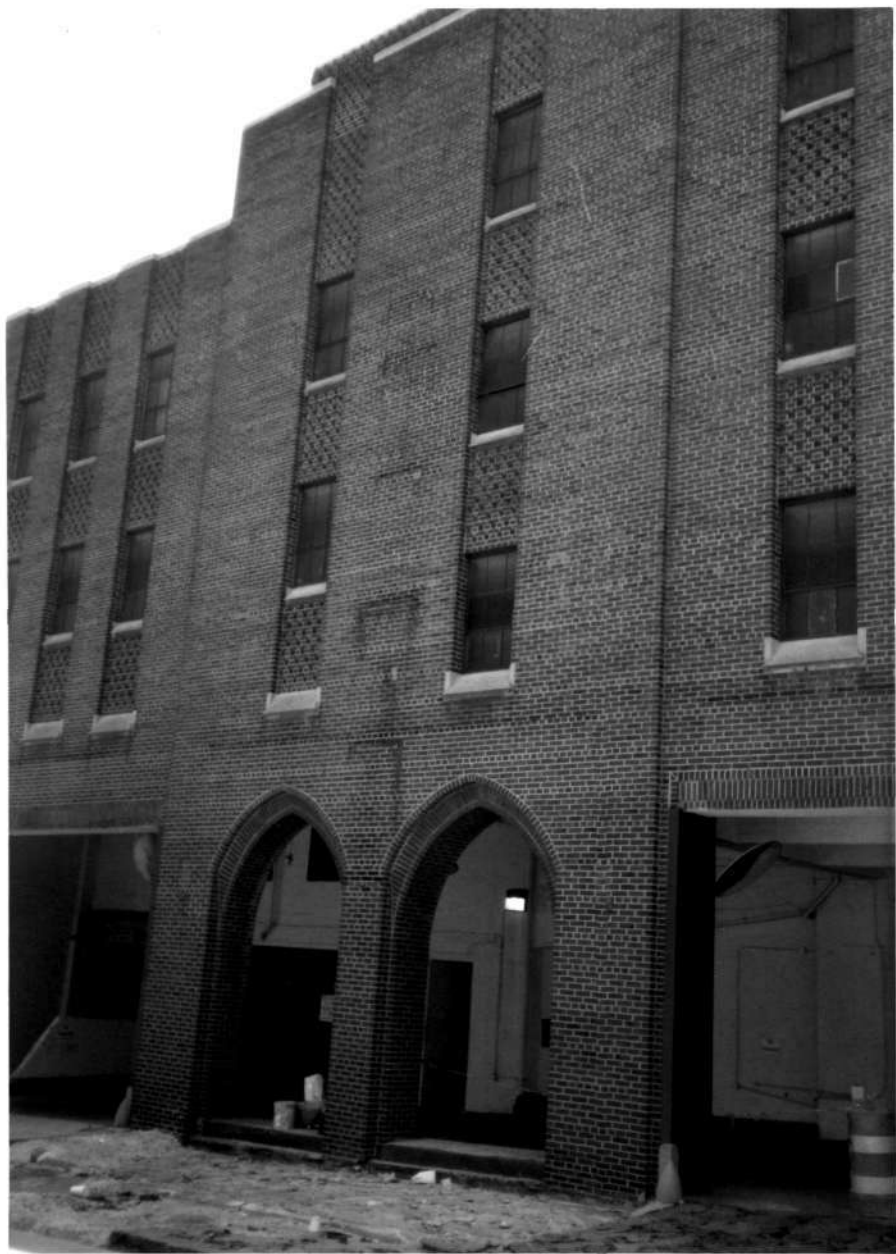
4/7

Facade, rear, north elevation

The first section, to the east of the central portico, is five bays and three stories. The first story is recessed and contains loading docks. The second and third stories are divided by brick piers. Each bay contains a 6-light industrial window with toothed brick spandrels and angled, bracket stone sills. The sills of the second story, however, are larger. The wall above the third story is also laid in toothed brick up to the cornice line of the flat roof.

The third section, to the west of the central portico, is five bays and four stories. The first story is recessed and contains the ramp for the parking garage. The second, third, and fourth stories are divided by brick piers. Each bay contains a 6-light industrial window with toothed brick spandrels and angled, bracket stone sills. The sills of the second story, however, are larger. The wall above the third story is also laid in toothed brick up to the cornice line of the flat roof.

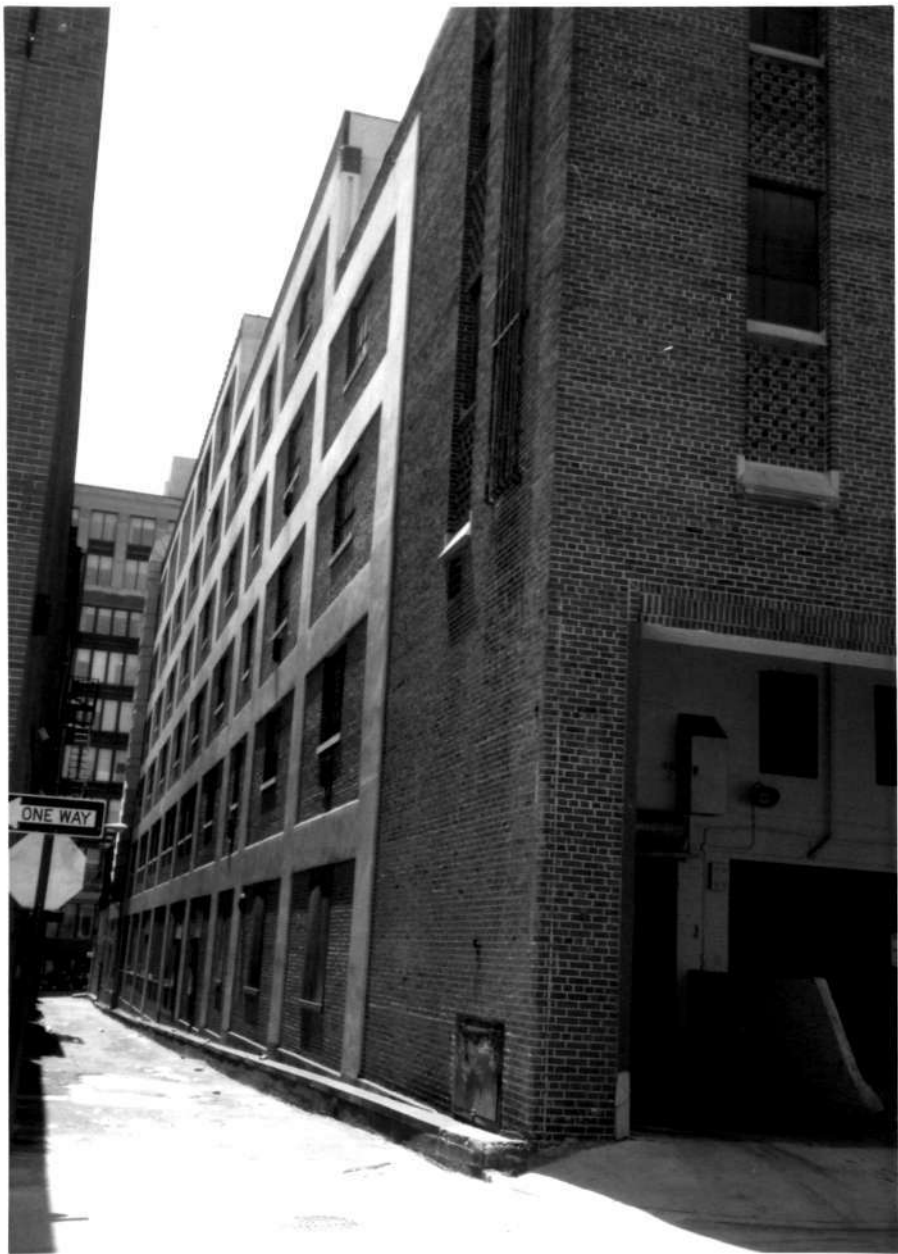
5/7

East elevation

The east wall of the garage runs along the alley. It is fifteen bays. The first three bays wrap around the small partywall building on the corner of the alley and Saratoga Street. The brick wall is divided into a grid by parged strips running vertically and horizontally. The height of the alley facade varies. There are industrial glass windows in the bays. A painted sign on the top story advertises "Hutzler's," a major department store around the corner.

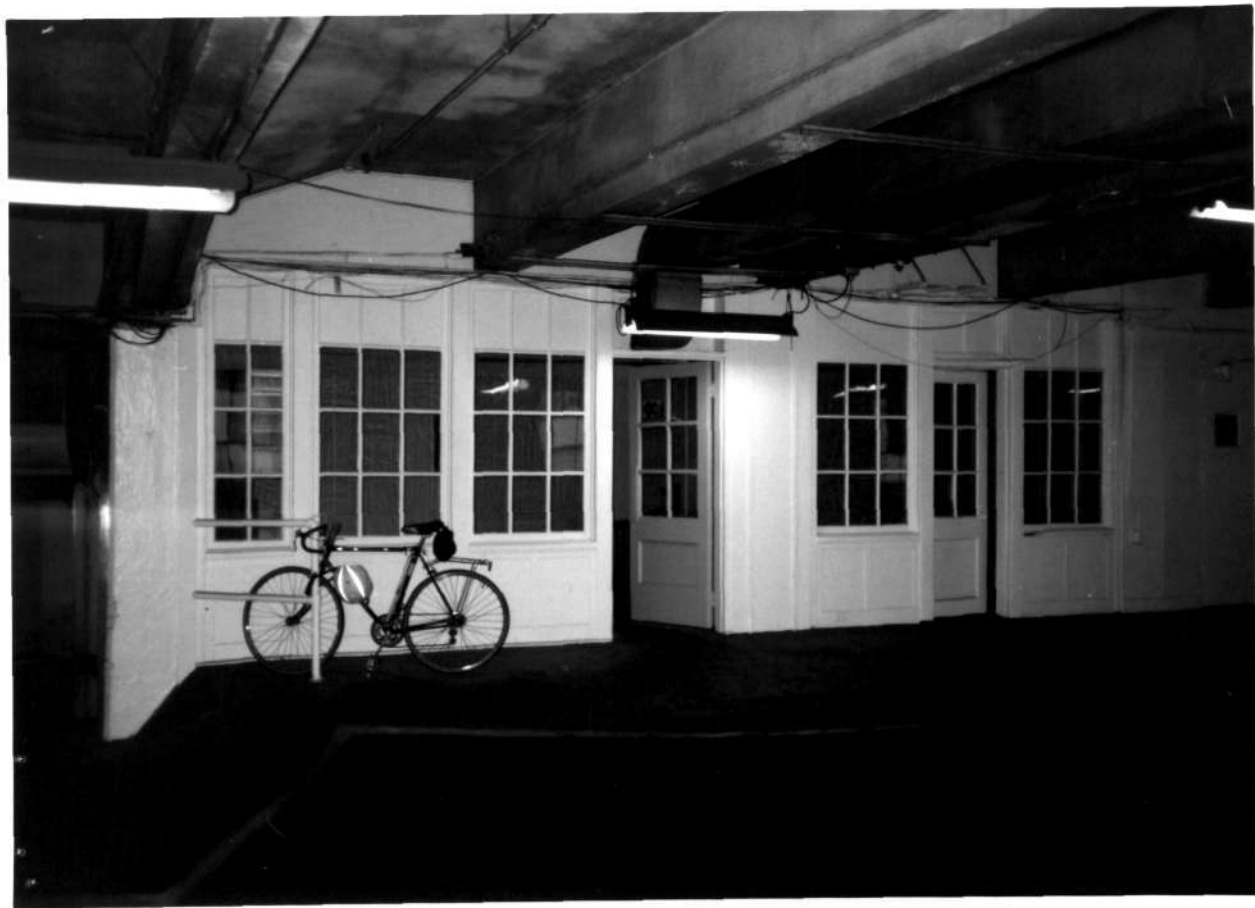
6/7

Interior, waiting room 2nd Floor

The interior of the Mulberry Street section contains the parking ramp. The second story contains a period waiting room for car drivers and passengers. The room is located off the Mulberry staircase. It is divided into two adjoining waiting rooms that have wood, recessed panelling on the walls and windows overlooking the garage. The windows have small lights and wood mutins.

The interior of the garage exposes its internal structure. The reinforced concrete posts and beams form a functional aesthetic which is deemed appropriate for the structure and is typically never covered up. The second-story (from the Mulberry side) contains two wood-panelled waiting rooms that are in excellent condition. The panelling resembles that of a colonial home and suggests a concern for comfort. The waiting room itself attests to the days of valet parking.

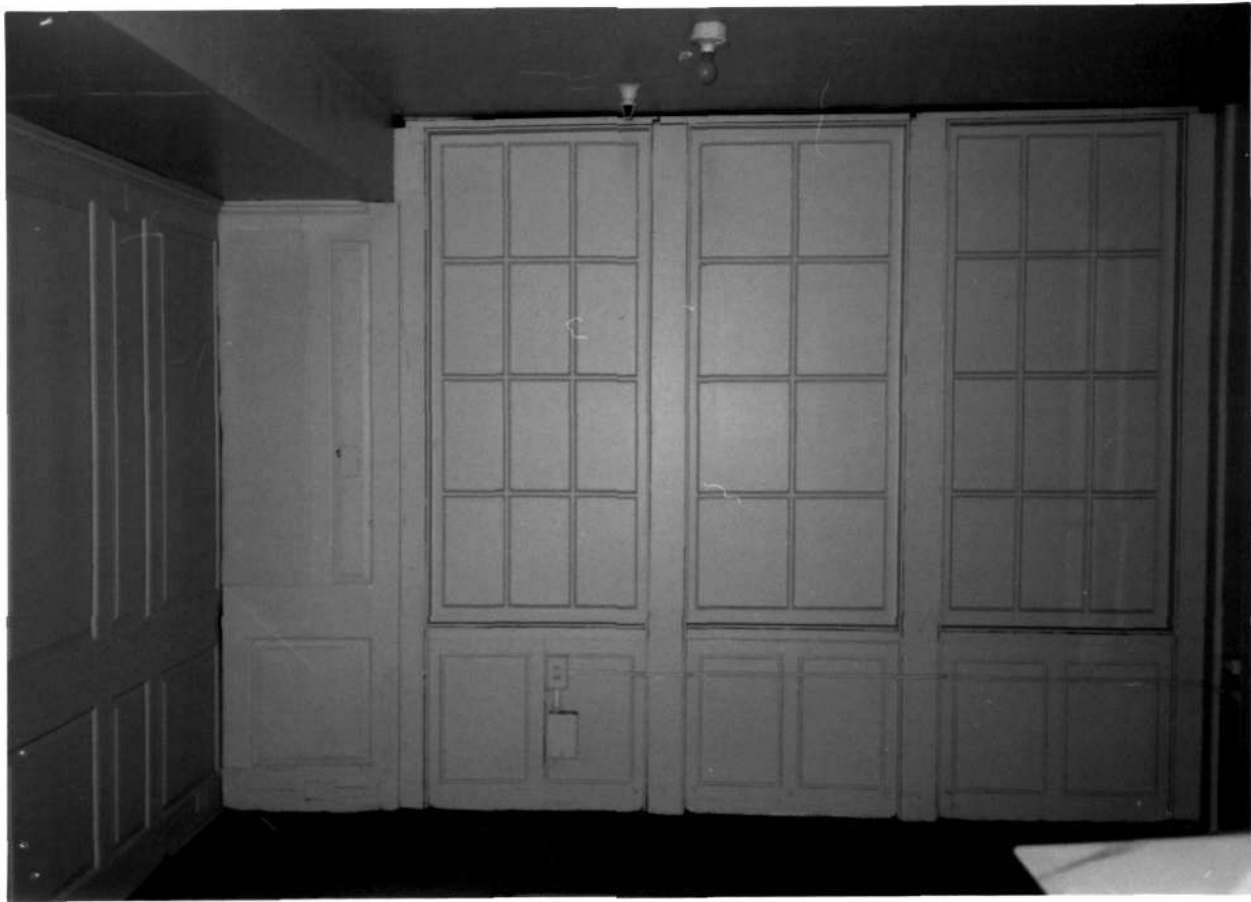
7/7

Interior, inside waiting room, 2nd floor
